PHOTOGRAPHIC INTERPRETATION REPORT

**SARY-SHAGAN
ANTIMISSILE TEST CENTER, USSR
CHANGES AND ADDITIONS
AS OF**

NPIC/R-923/64

November 1964

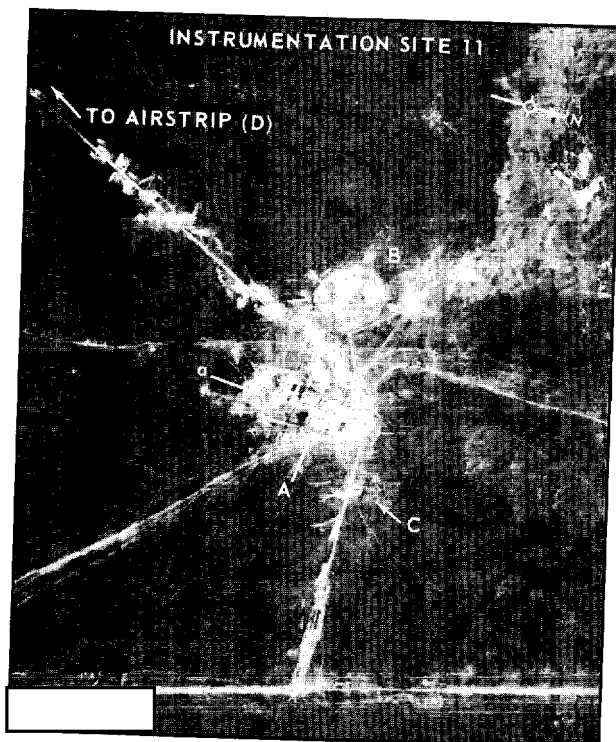
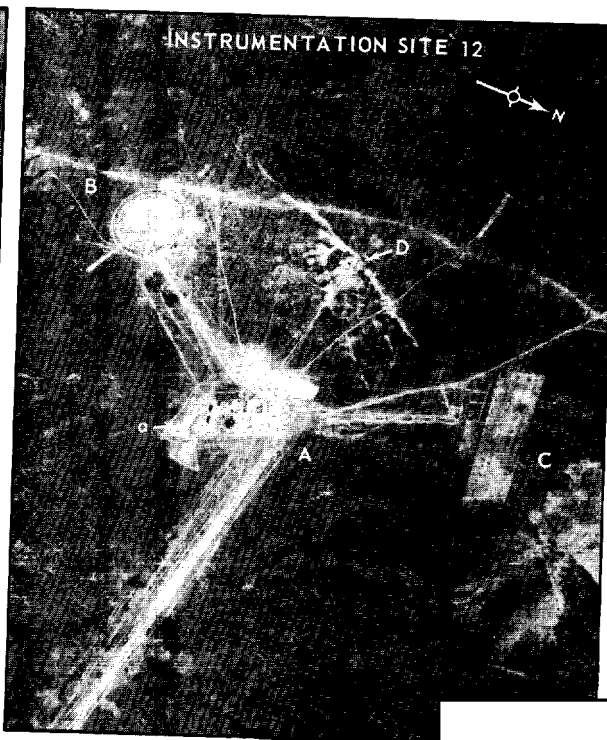
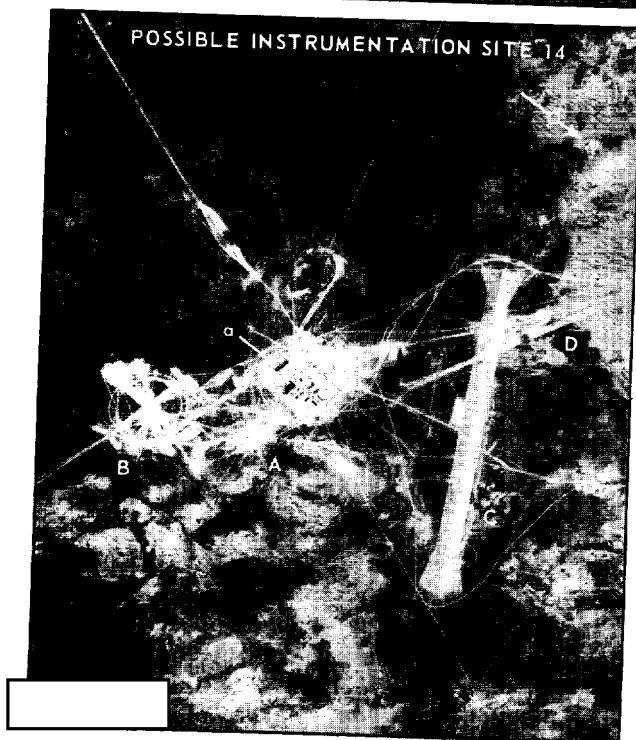
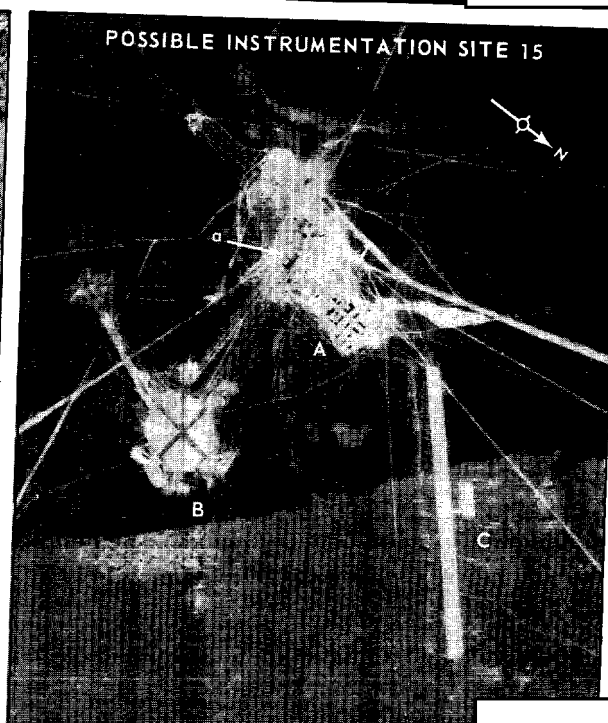
FIGURE 18. INSTRUMENTATION SITES 11, 12, AND POSSIBLE INSTRUMENTATION SITES 14 AND 15

This site (Figure 18) consists of an opera-tional and support area (A) with 20 buildings and 5 additional buildings with 20-foot-diameter domes (a), an interferometer with 1,000-foot-long crossarms (B), a probable microwave station with a probable tower and at least two buildings (C), and a dirt strip measuring 4,500 by 600 feet (D). No significant recent change is apparent at this site. The airstrip, not pictured on the graphic, is 11,500 feet southwest of the support area.

This site (Figure 18) situated 31 nm south of Dzhezkazgan and 72 nm west-northwest of Site 14, on latest coverage of [] consisted of an operational and support area (A) of approximately 18 buildings, miscellaneous small structures, and an unusual-appearing rectangular structure approximately 230 by 100 feet (a), an interferometer with 1,000-foot-long crossarms (B), and a prepared-earth airstrip (4,220 by 210 feet and oriented northeast/southwest) (C). The unusual structure, generally similar to the one at Site 14, appears to have a gable roof with three extensions or raised sections attached to or adjacent to the south end of the building. The interferometer appeared complete or nearly complete. No significant change could be discerned in site facilities between latest clear photography of [] and latest photography of [] (snow-covered).
